## Deconstruction

# DEMOLITION JOB

Tourists, tube trains and ancient monuments are just some of the challenges faced by demolition contractors operating in London. **BRENDON HOOPER** explains all

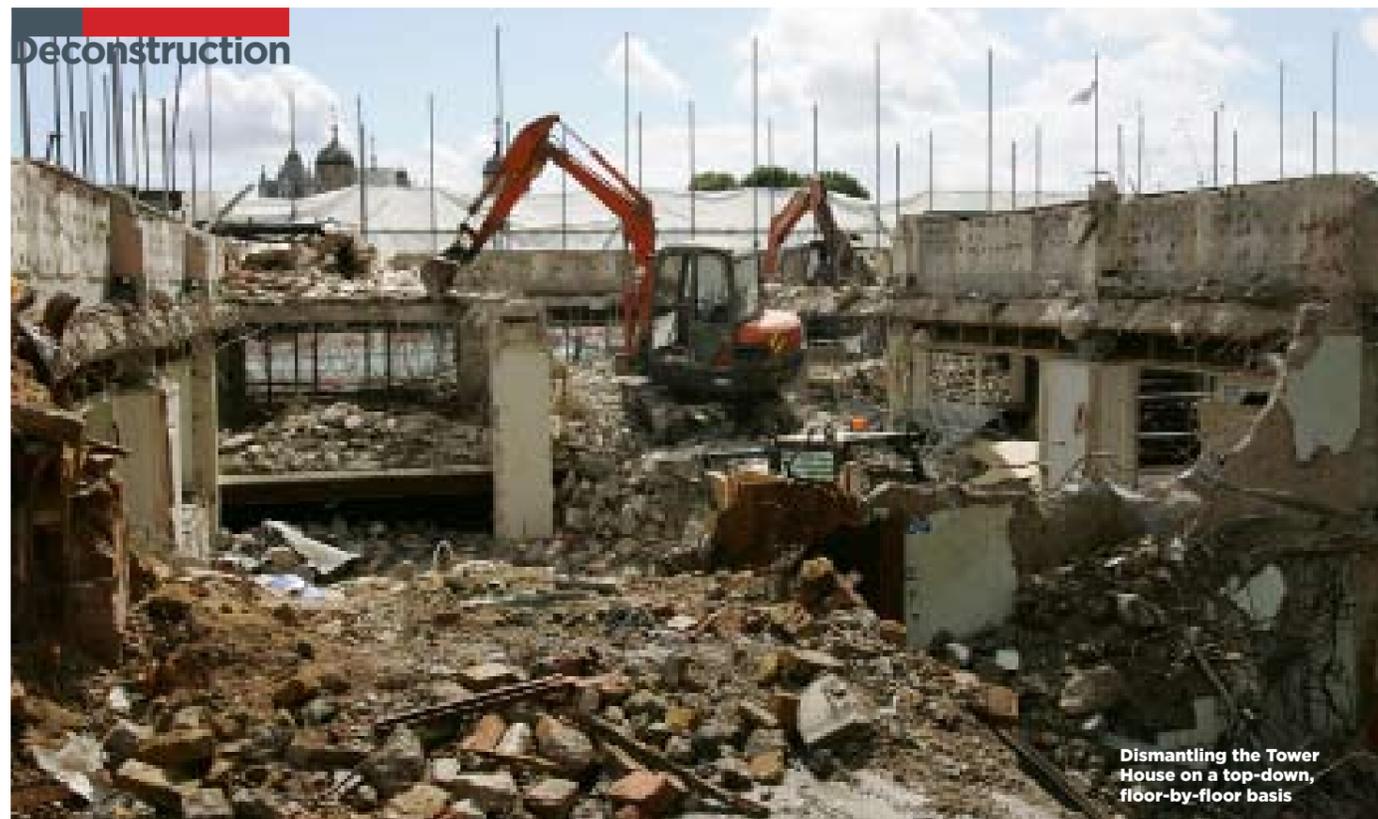
Dismantling the Tower House on a top-down, floor-by-floor basis

The building was demolished on a top-down floor-by-floor basis by mini-excavators fitted with hydraulic attachments such as ‘munchers’, ‘crackers’ and ‘pulverisers’, and supplemented, where necessary, by hand-held tools. This equipment may sound violent but it emits far less sound and vibration than more traditional demolition methods.

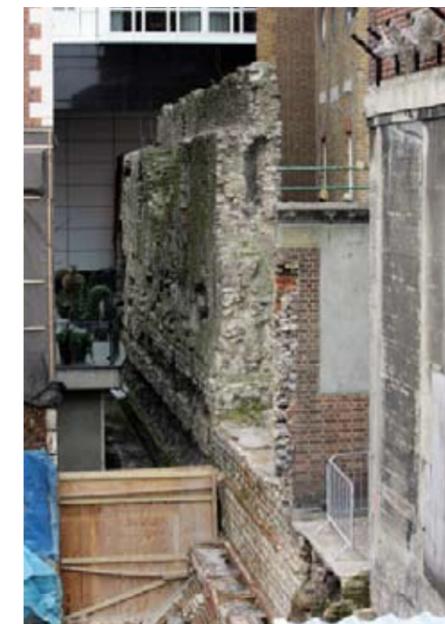
Clockwise from above: The Roman wall still standing one demolition job and a few millenia later; Temporary Tower Hill Underground Station exit in use; Demolition by hand

A further complicating factor at Tower House was the presence of a Roman wall situated just yards from the building’s east facing elevation. It had been designated by English Heritage as a Scheduled Ancient Monument and therefore needed to be preserved. Scaffolding was carefully erected around the wall and a protective plywood covering attached.

Again, drilling and saw cutting were used to remove any large concrete structures close to the wall, including the basement slab which extended almost to its edge. Survey points were placed on the wall to detect any micro-movements throughout these operations.
